## LABORATORY TEST REPORT

| Sample Details: | URBANE II RHS WB | Report No.: | RD24-227-2 |

Basin load test

### AS1172.4:2019 - Appendix B Wall basin load safety test

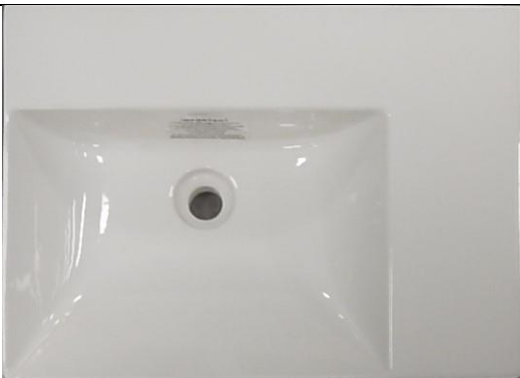
### Basin

| URBANE II RHS WB | | <p>URBANE II RHS WB NTH NOF<br/>878700W</p> <p>Qty. 1</p> <p>Made in ITALY<br/>Inspected by: SCA</p> <p>13/11/2020</p> <p>9 311440 508393</p> <p>For other details refer:<br/>Current Technical Manual</p> |

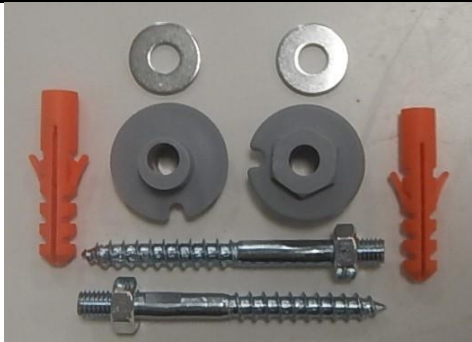
### Fixing kit

| D200 Wall Basin Fixing Kit | |

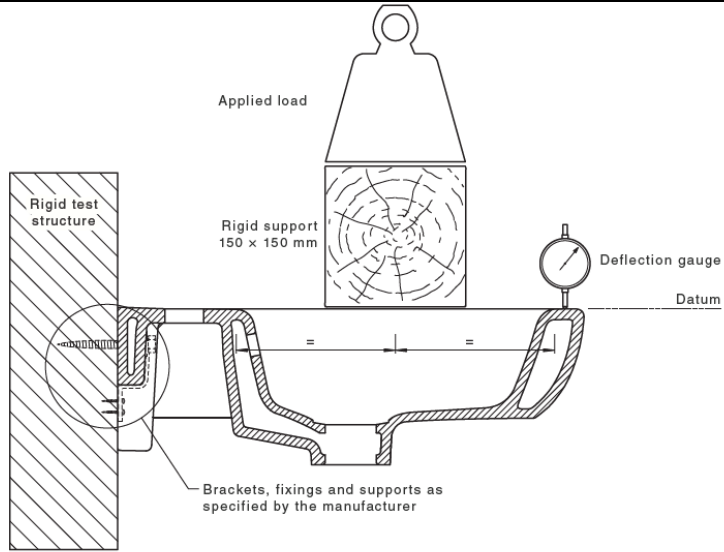
Figure B.1 — Typical arrangement for load safety test for washbasin

Maintain 150kg load for 60min

| Basins | Fixing kit | Underload deflection | Permanent deformation | Observations and comments |
| Urbane II RHS WB (878700W) | D200 Wall Basin Fixing Kit | 11.0mm | 1.3mm | No cracking, splitting, crazing or leakage of the basin observed after load test |
