### Spare Parts Installation - Pk 687 082

# caroma<sup>®</sup> Apollo Inlet Valve

## Maintenance Instructions

Leaflet No. 687 581~A

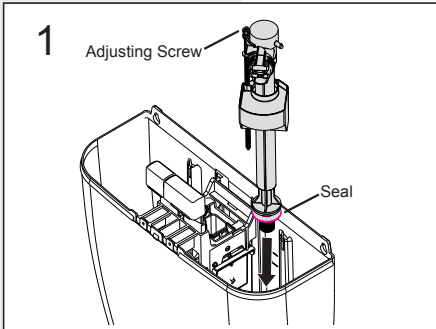
Ensure water supply is turned off & remove old inlet valve. Insert replacement valve. Ensure seal is installed on the inside of cistern.

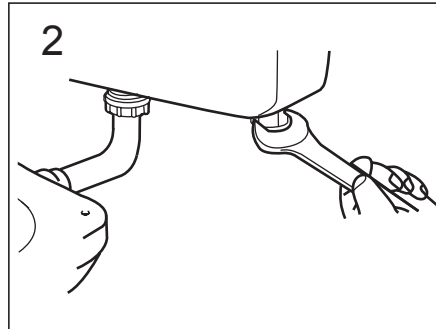
Fix valve in place and firmly hand tighten. Further tighten the nut by 1/4 turn with a spanner

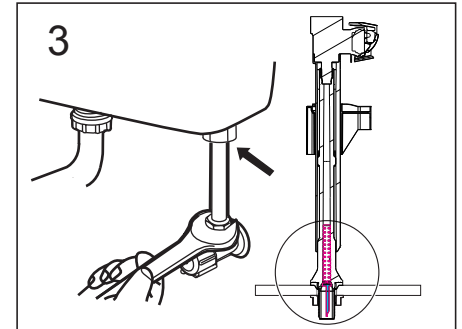
Make sure that the strainer is in place to help prevent damage caused by water borne contaminants. Fit the water supply pipe using approved fittings.

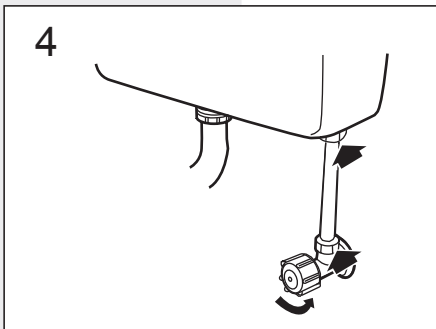
Turn on the water supply and check for leaks at the connection fittings.

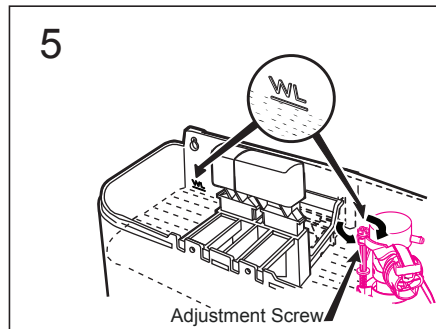
Using the adjustment screw set water level. Flush cistern and confirm water level setting.

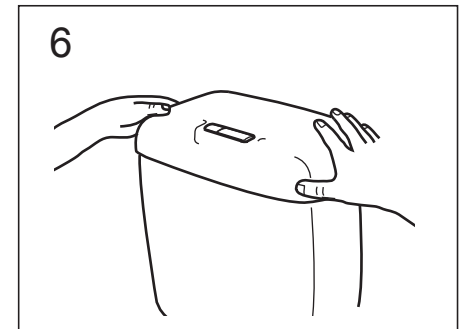
If all cistern functions are correct, replace the lid.

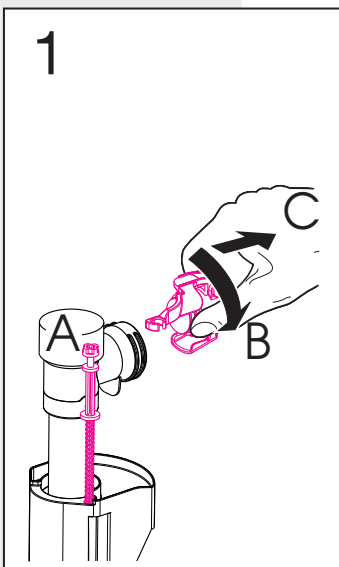
Turn water supply off.

Unclip adjusting screw from float arm. Rotate anti clockwise & pull to remove. Discard cap assembly and old seal.

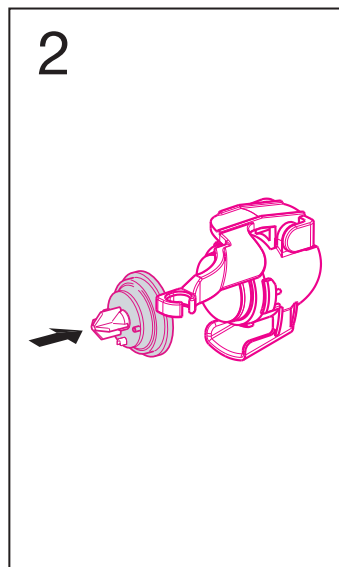
Ensure new seal is positioned correctly on replacement cap assembly.

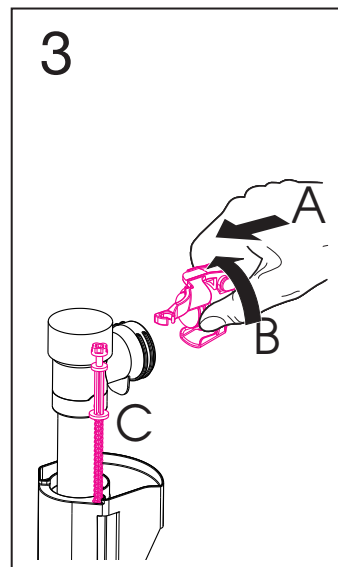
Push & rotate clockwise to re-attach cap assembly. Clip in adjusting screw.

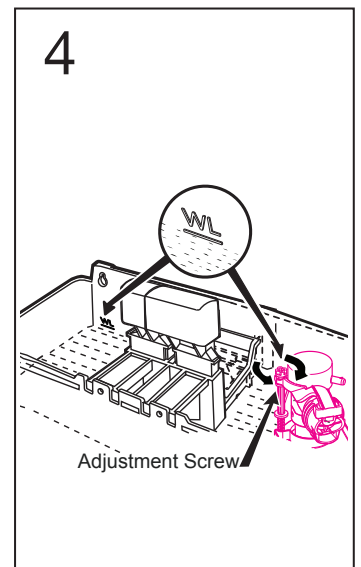
Turn water supply back on. Check valve operates correctly & adjust water level if necessary.

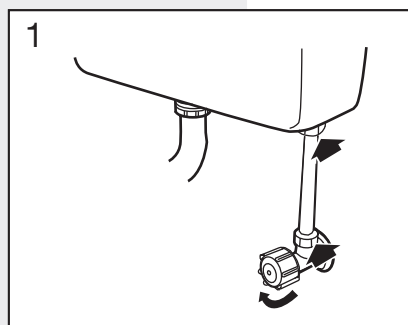
Turn off water supply and if strainer is to be cleaned remove connection fittings.

Unclip adjusting screw. Rotate anti clockwise & pull to remove cap assembly.
